Advantage Inspection Service, Inc.

CONFIDENTIAL INSPECTION REPORT

4695 E. Sanna, Paradise Valley, AZ

5/18/2009 8:00 am to 11:30 am

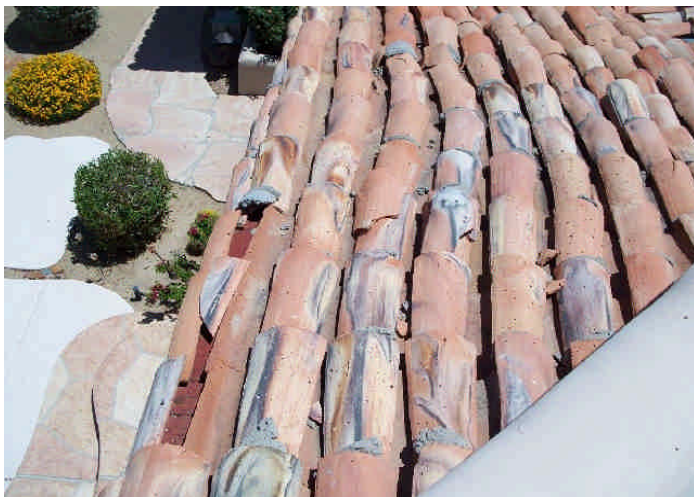
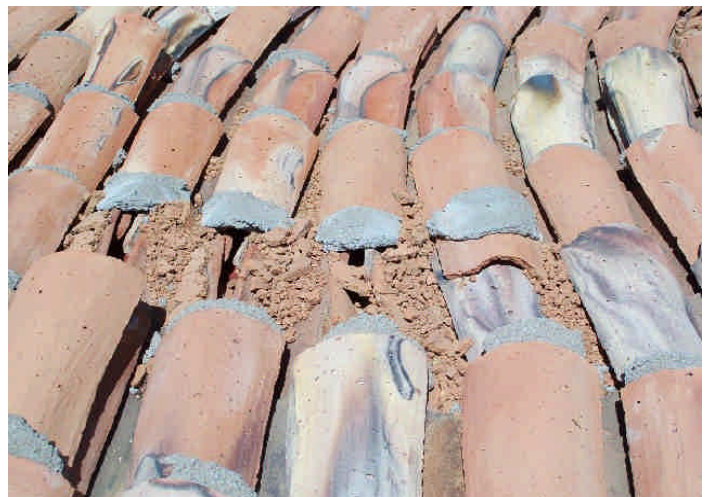
+ Maintenance and review required at tiled roof - Attention.

+ We observed approximately 30+ broken roof tiles needing replacement, further review needed - Attention.

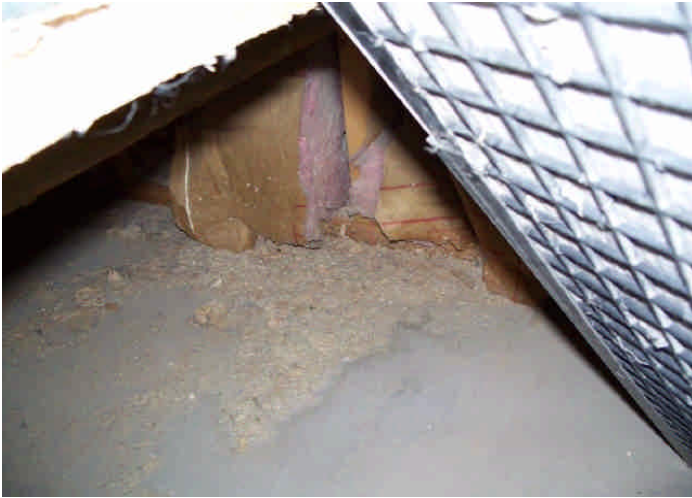
+ Dirty heating/cooling system filter(s) were noted - Attention.

+ The return-air compartment is dirty and should be serviced - Attention.

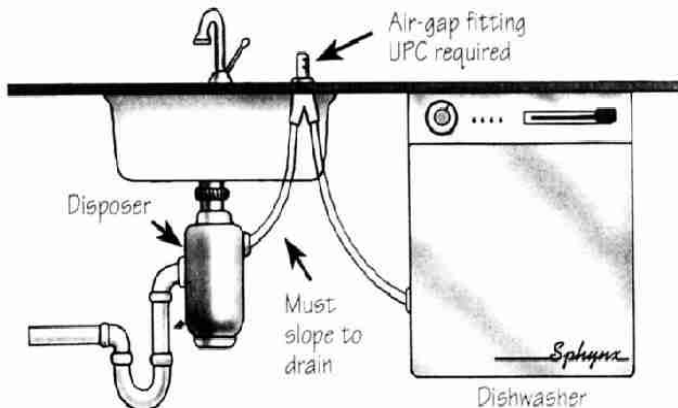
UPC Air-Gap Device on Drain

- + Dishwasher was Operational except Adverse Conditions noted - Review.
- + No air gap device or high loop is present at dishwasher drain line. This condition could allow debris to backup from the sink drain into the dishwasher and it can be easily fixed by a service technician - Attention.

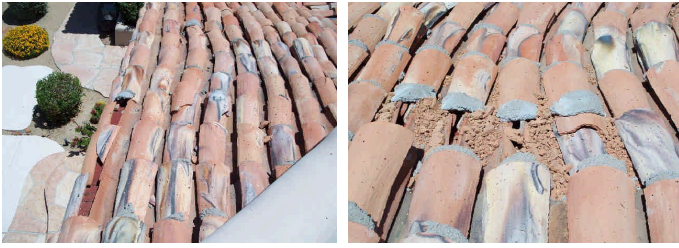
- + Maintenance and review required at tiled roof - Attention.
- + We observed approximately 30+ broken roof tiles needing replacement, further review needed - Attention.

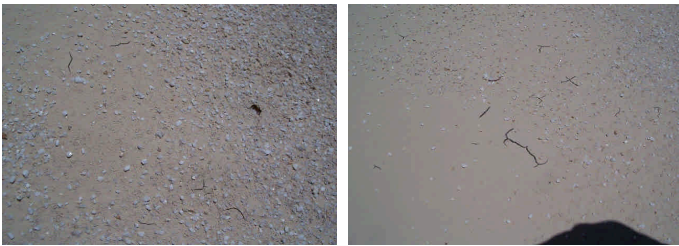
- + Maintenance and review is required at the foam roof area - Attention.
- + Cracking was observed at the coating surface, repairs needed - Attention.
