CONFIDENTIAL INSPECTION REPORT

Solar Tech

24490 N. 29th Drive, Phoenix, AZ 85085

04/09/2009 9:00 am to 12:30 pm

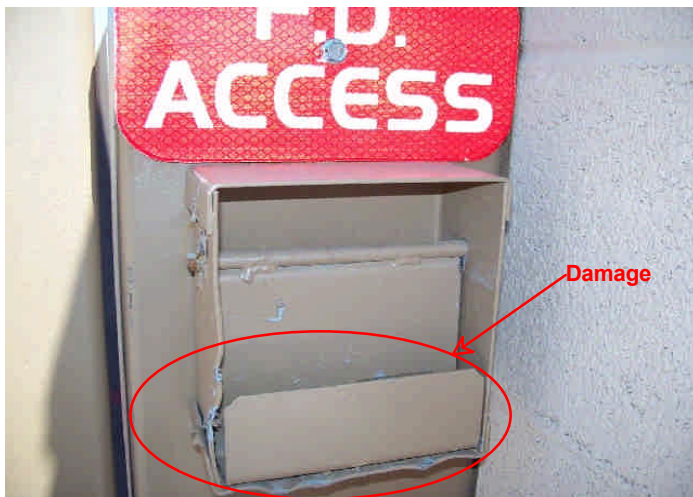
+ Evidence of damage/forced entry was observed at the FD access on the roll gate - Attention.

+•Evidence of damage/forced entry was observed at the FD access on the roll gate - Attention.

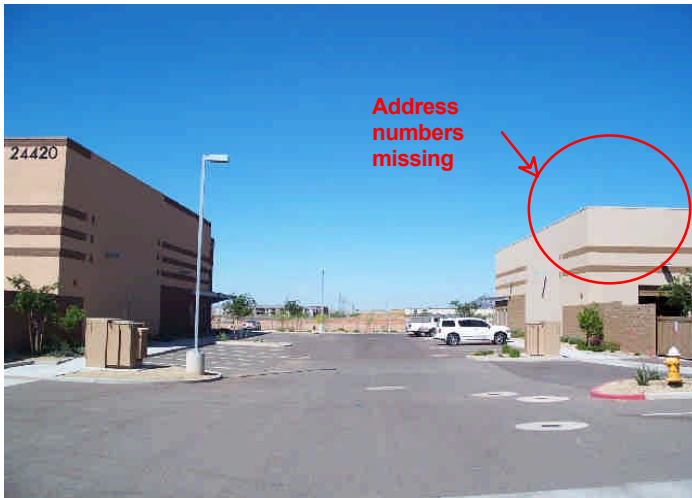
+ East facing building address signage is missing - Attention.

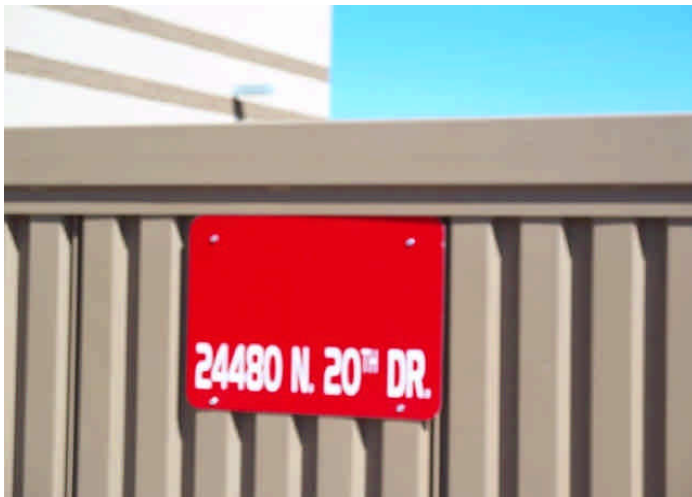
+ Roll gate address signage is incorrect - Attention.

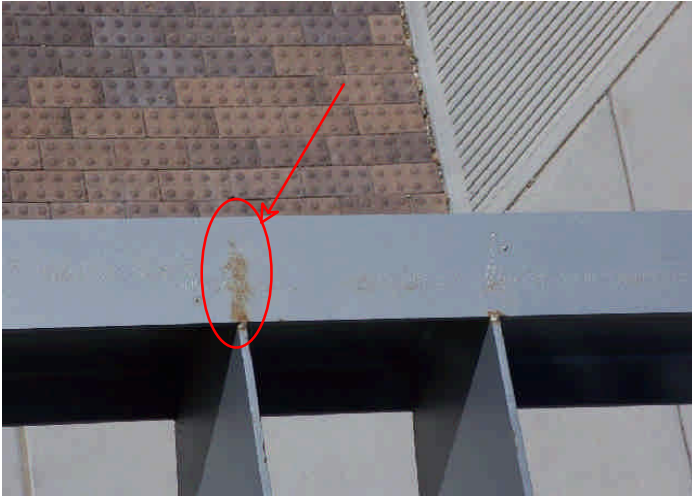
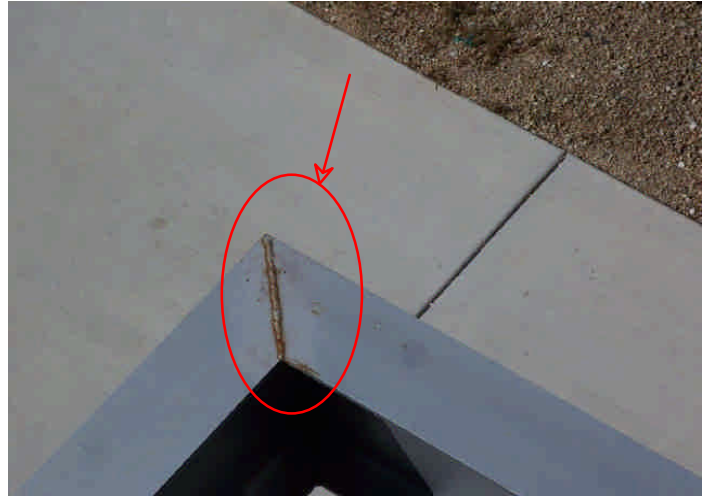
+ Paint coverage is thin at exposed exterior structural steel trim (rusting at top) - Attention.

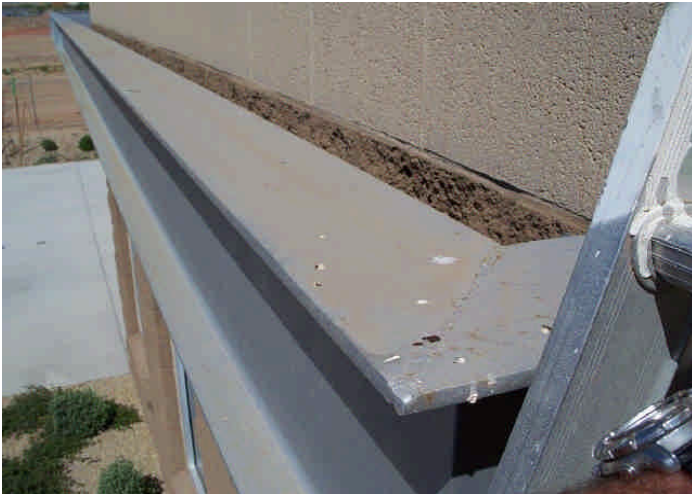
+ East corner welding is incomplete (tacked only) at the front exposed structural steel mounting bracket behind area shown in photo - Attention.

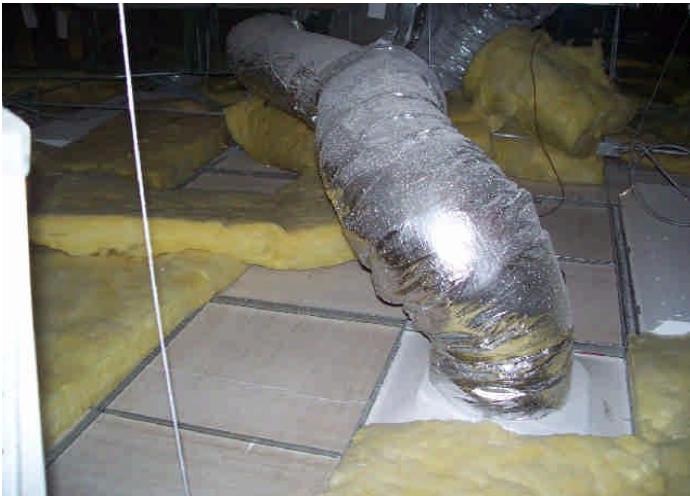
- + The average attic insulation depth is approximately 4 to 6 inches. Current standards call for 8 to 10 inches, upgrading should be considered - Review.
- + We suggest adding insulation at the underside of the roof deck - Review.
- + Insulation is displaced in areas, correction suggested - Attention.

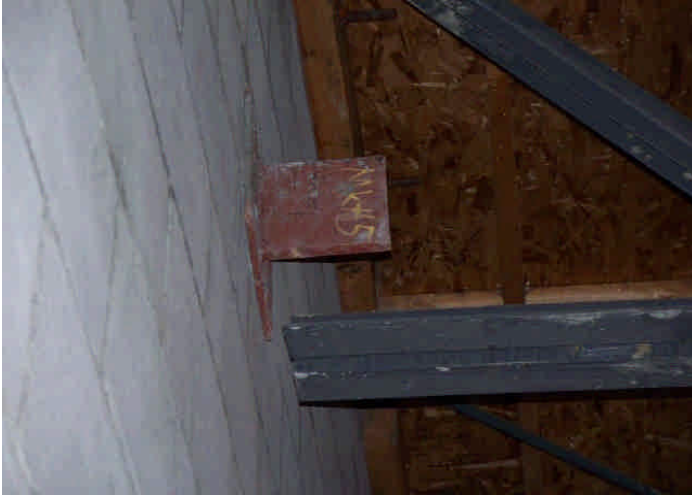
- + The north end of the west side girder truss bottom flange guide is improperly placed and ineffective (no welds exist at guide to lower flange connections) - Attention.

- +•The north end of the west side girder truss bottom flange guide is improperly placed and ineffective (no welds exist at guide to lower flange connections) - Attention.

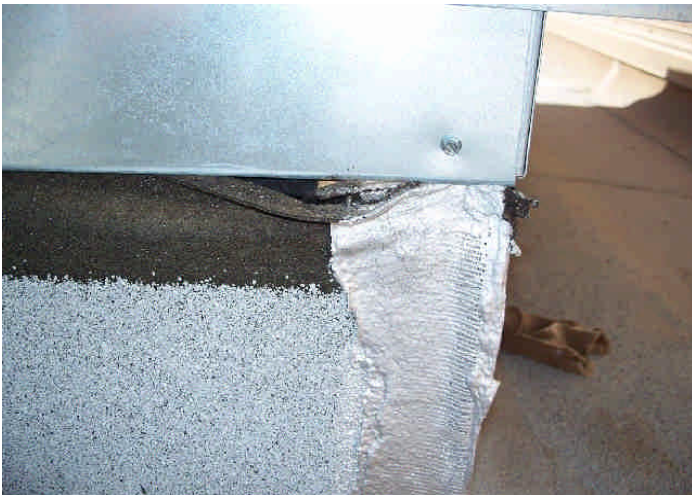
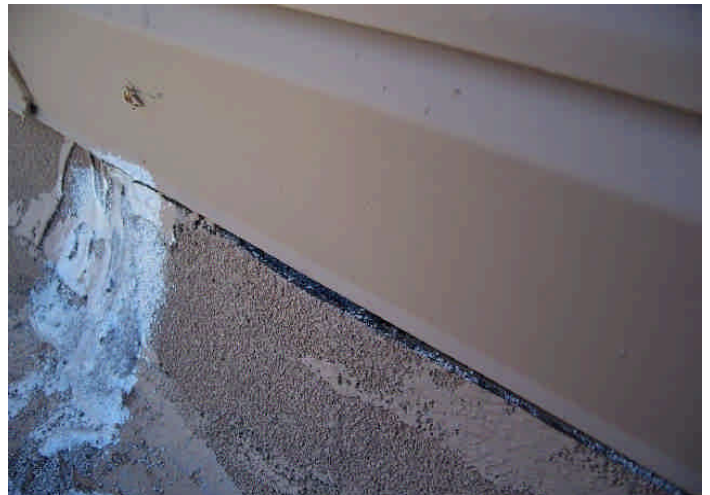
+ Flashing area separations need correction at the west vent curb and at the cant area near the roof access scuttle - Attention.

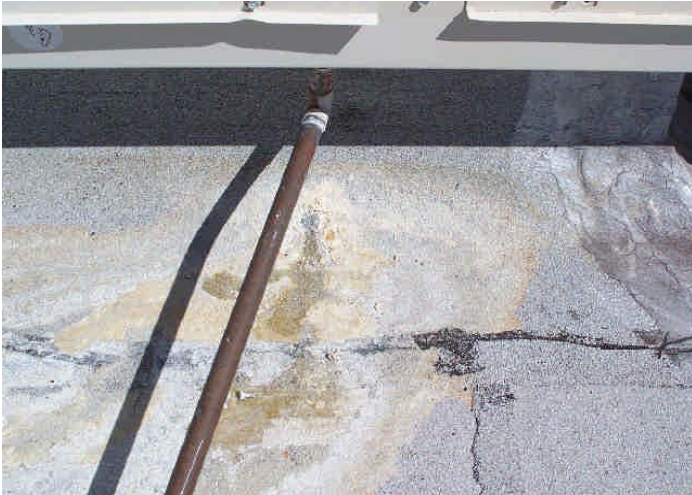
+ The east evaporative cooler drain/overflow line was leaking - Attention.

- +•The east evaporative cooler drain/overflow line was leaking - Attention.
